Manhole Inspection Summary

Manhole # S39Y1_031MH

Insp Date: **6/25/08 8:57 AM**

Location Address: **500 E. Patapsco Ave.**

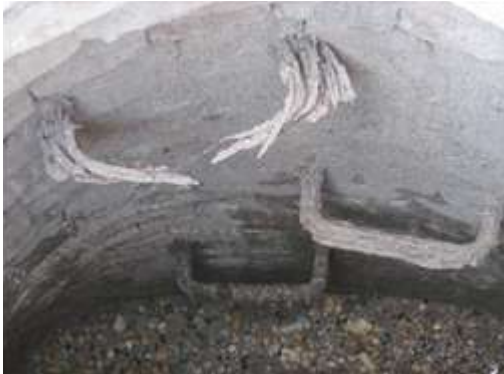
Steps Count: **3** Missing: **0** ☒ **Corroded**

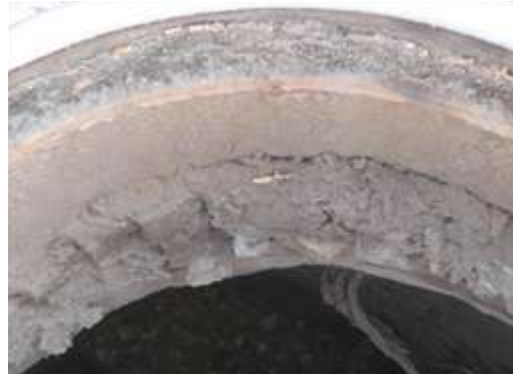
Defect 1

Frame Offset: **1.5** (in.) Condition: ☒ Sound ☐ Cracked ☐ Leaks

Frame offset

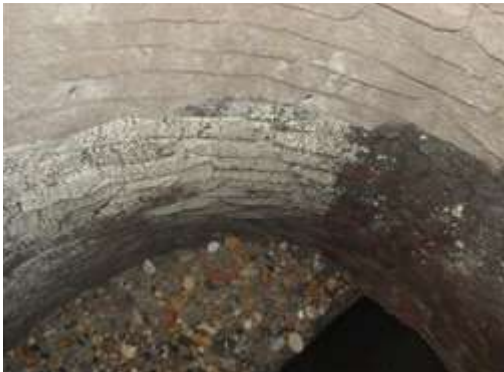
Defect 2

Infiltration: ☐ None ☒ **Joint** ☐ Cracks ☐ Mortar ☐ Roots ☐ Wall

Infiltration: ☐ None ☐ Joint ☐ Cracks ☐ Mortar ☐ Roots ☒ **Wall**

Infiltration

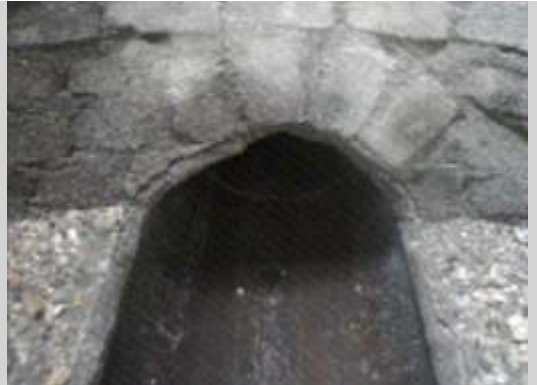
12 O'Clock Outflow

12 in. Circular Gravity Sewer
Pipe Out @ 12 O'Clock

Pipe Height: **12** (in.) Rod and Bar (Angled)
Pipe Material: **Clay** ☐ Pipe Lined
Invert Depth: **7.58** (ft.) Flow Characteristics: **None**
Deposits: ☒ None ☐ Mud ☐ Sludge ☐ Debris ☐ Grease
Silt Depth: (in.) Deposits Extent:
Infiltration: **None** Pipe Seal Cond: **Sound**

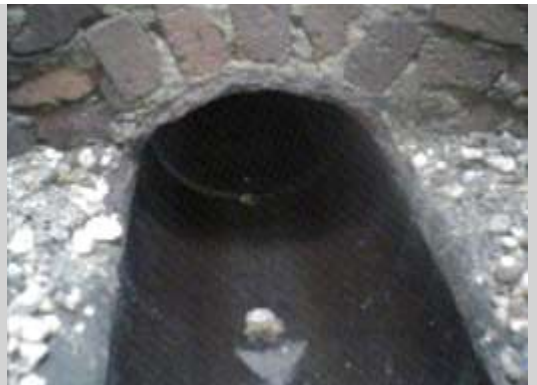
6 O'Clock Inflow

12 in. Circular Gravity Sewer
Pipe In @ 6 O'Clock

Pipe Height: **12** (in.) Rod and Bar (Angled)
Pipe Material: **Clay** ☐ Pipe Lined
Invert Depth: **7.42** (ft.) Flow Characteristics: **None**
Deposits: ☒ None ☐ Mud ☐ Sludge ☐ Debris ☐ Grease
Silt Depth: (in.) Deposits Extent:
Infiltration: **None** Pipe Seal Cond: **Sound**
